Subject: Idle Rattle in Heavy-Duty Trucks

Document Number: CLIB0001

Date: October 18, 2005

Updated: April 29, 2013

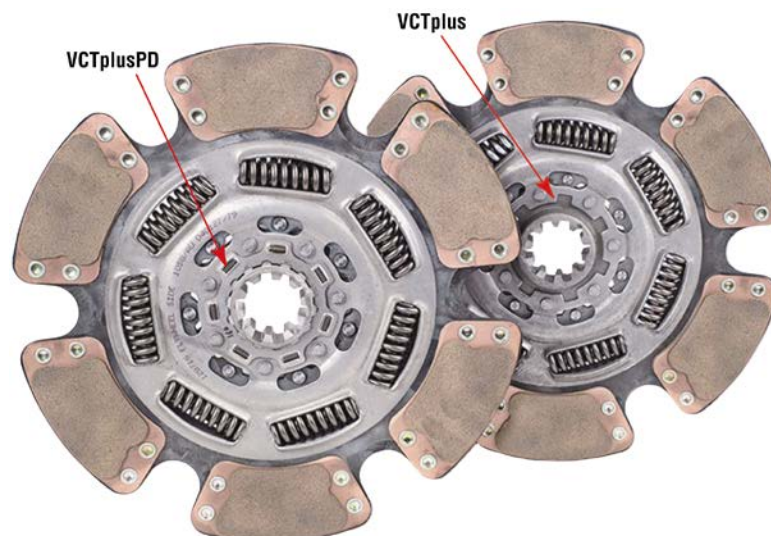
Eaton has developed the VCT Plus PD (pre-damper) clutch disc that has a special first stage in the damper, which is designed to isolate the engine idle pulsations before the pulsations reach the transmission. The pre-damper disc can be identified by the presence of 7 small springs around the hub.

- Raising the engine idle RPM will change the idle characteristics of the engine and the noise may diminish. Recommended maximum default idle speed is 750 RPM.
- Install the VCT Plus PD (pre-damper) clutch discs, which are available for applications up to 2250 lb-ft with the different Eaton 15.5" clutch models.
